Naval Research Laboratory

NRL/MR/7333--96-7725

Fungal Contamination of H-53 Aircraft

March 15, 1996

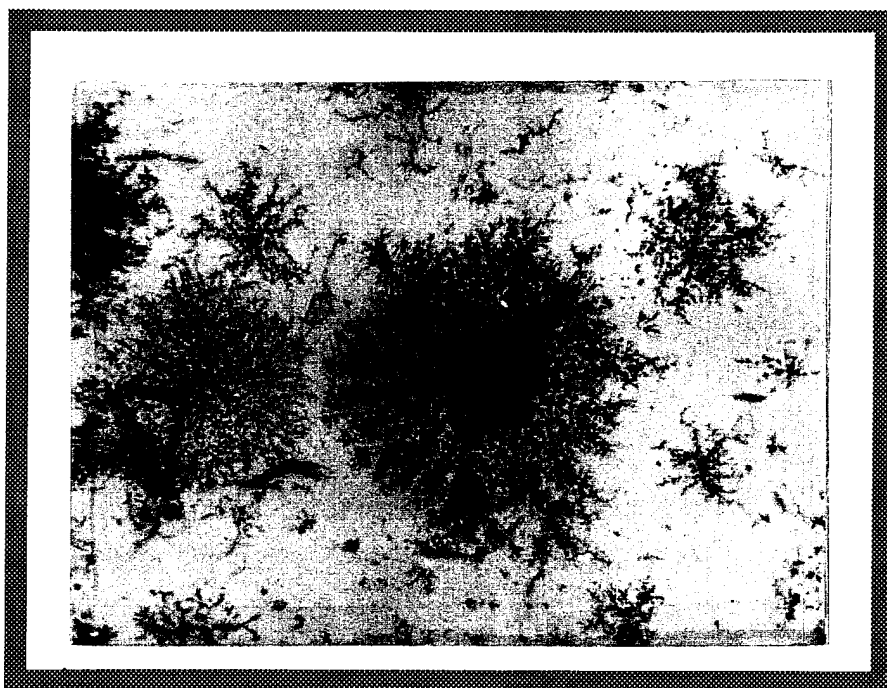
Figure 4: Dry type fungal growth on polyurethane coated aluminum (6x).

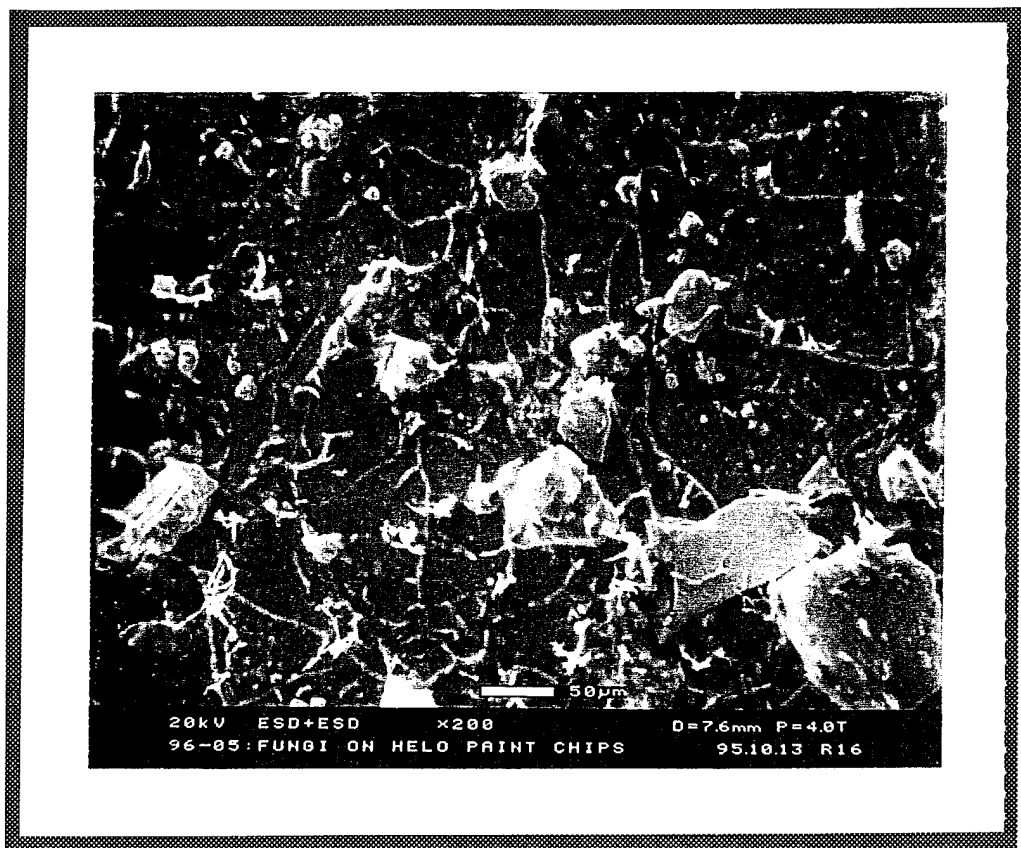
Figure 5a: Fungi and debris on polyurethane paint on interior of H-53 (200x).

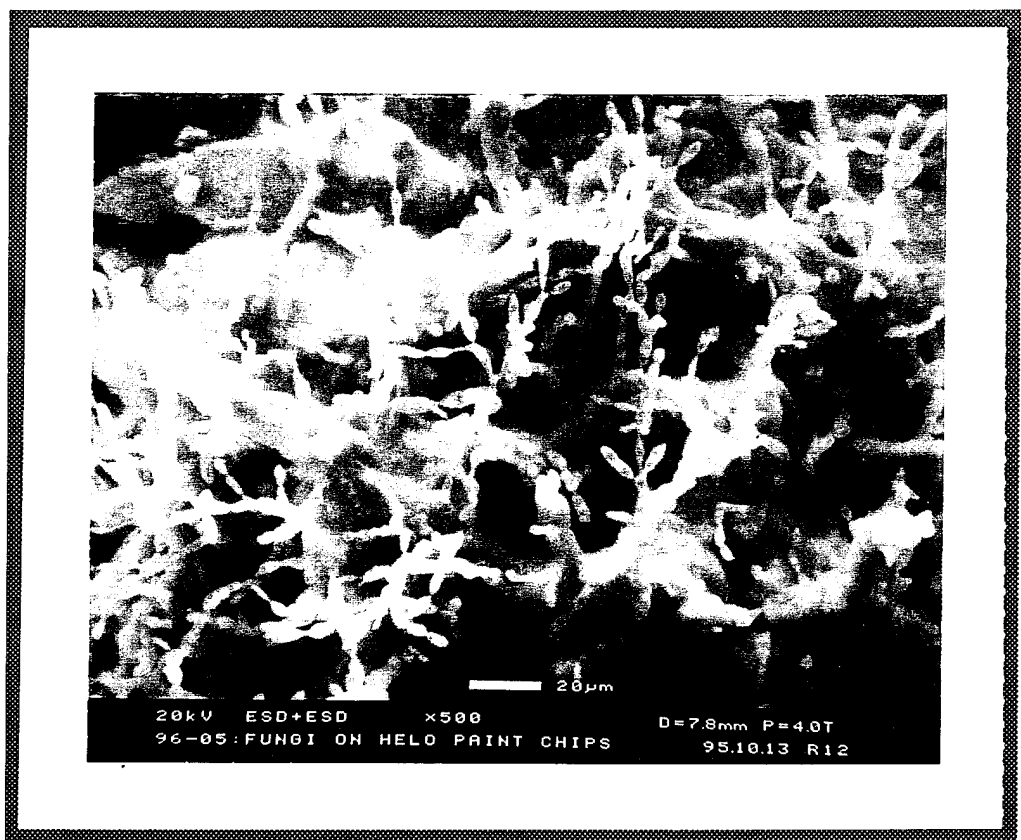
Figure 5b: Fungal mass on polyurethane paint surface (500x).

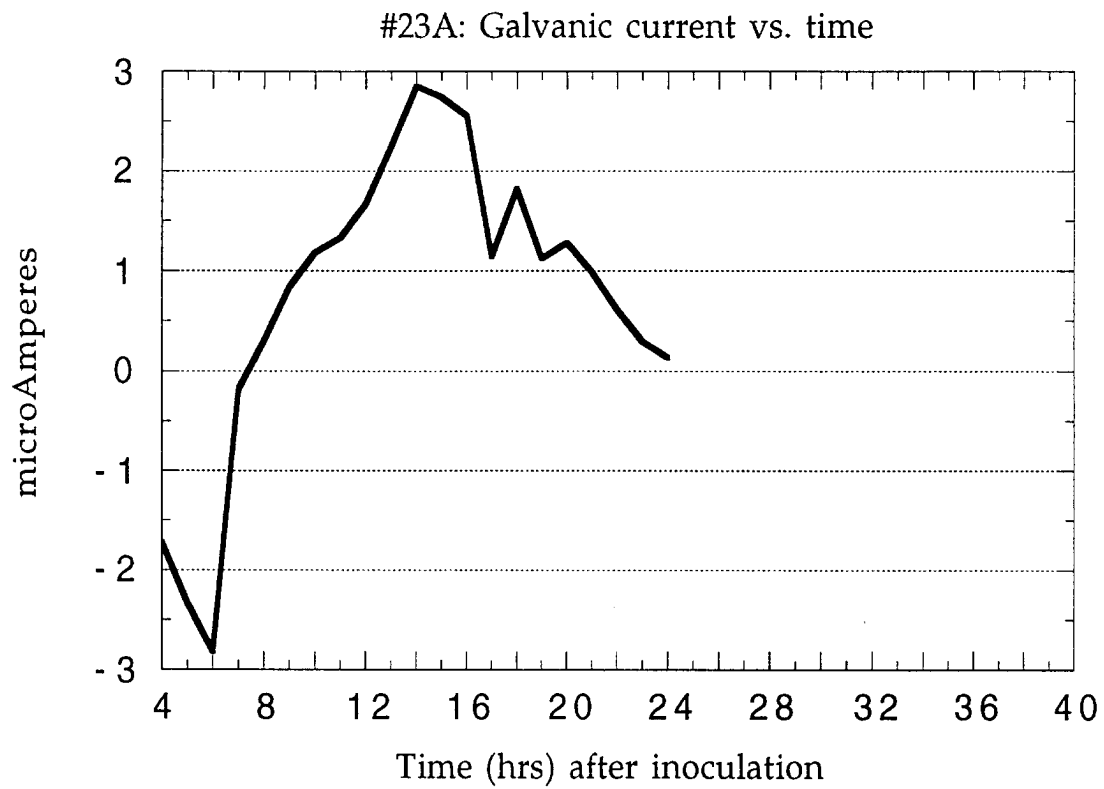
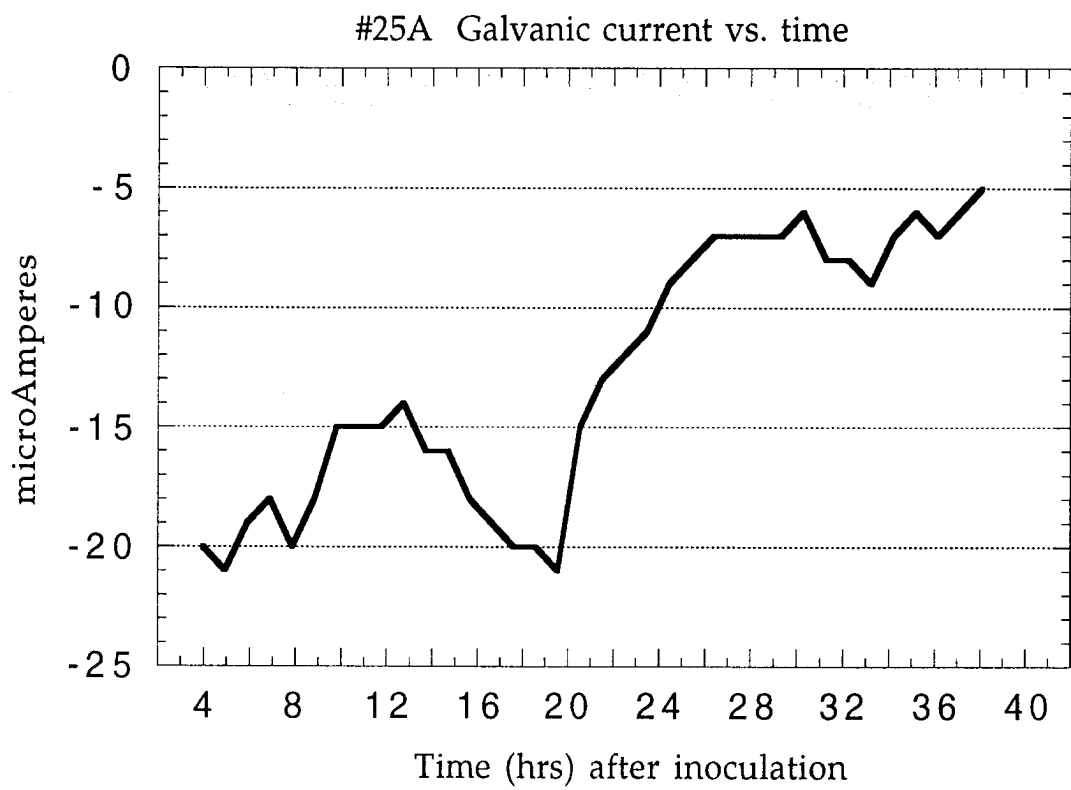
Galvanometer current and polarity results are preliminary but suggest that at least two fungal isolates are capable of causing corrosion of aluminum. Figure 7a & b. As described in Methods, cells were set up such that a positive current (i.e., anodic, giving up electrons) indicated that corrosion was occurring on the coupon inoculated with fungi. The cell inoculated with isolate 23A (*Aureobasidium*) went from cathodic (negative current) to anodic (positive current) during the course of the experiment. The cell inoculated with isolate 25A (*Trichoderma*) exhibited a trend toward anodic conditions, although a transition was never actually achieved. ESEM examination of the coupons revealed the surfaces were heavily coated with oxide with little visible evidence of mycelial growth, so the exact nature of attack could not be confirmed.

Videla (1986) demonstrated that the Deuteromycete *Cladosporium* in liquid culture caused corrosion of unprotected aluminum. Conditions similar to liquid culture might be expected in bilge compartments of helicopters when water, oil, and salt air combine with fungal spores. Our purpose in designing a non-immersion electrochemical cell was to test corrosion potential under sub-aerial conditions found in other parts of the aircraft. This design is new and conclusions drawn from its use are tentative; however, preliminary data suggest that the coupon exposed to one of the isolates (#23A) became anodic, as would be predicted if more corrosion were occurring in this coupon than in the sterile control. While the second isolate (#25A) did not have as strong an effect, the general trend in this test was toward anodic conditions, suggesting that the isolate was causing corrosion.

Figure 7: Galvanic currents in 2024 aluminum alloy in electrochemical test cells.

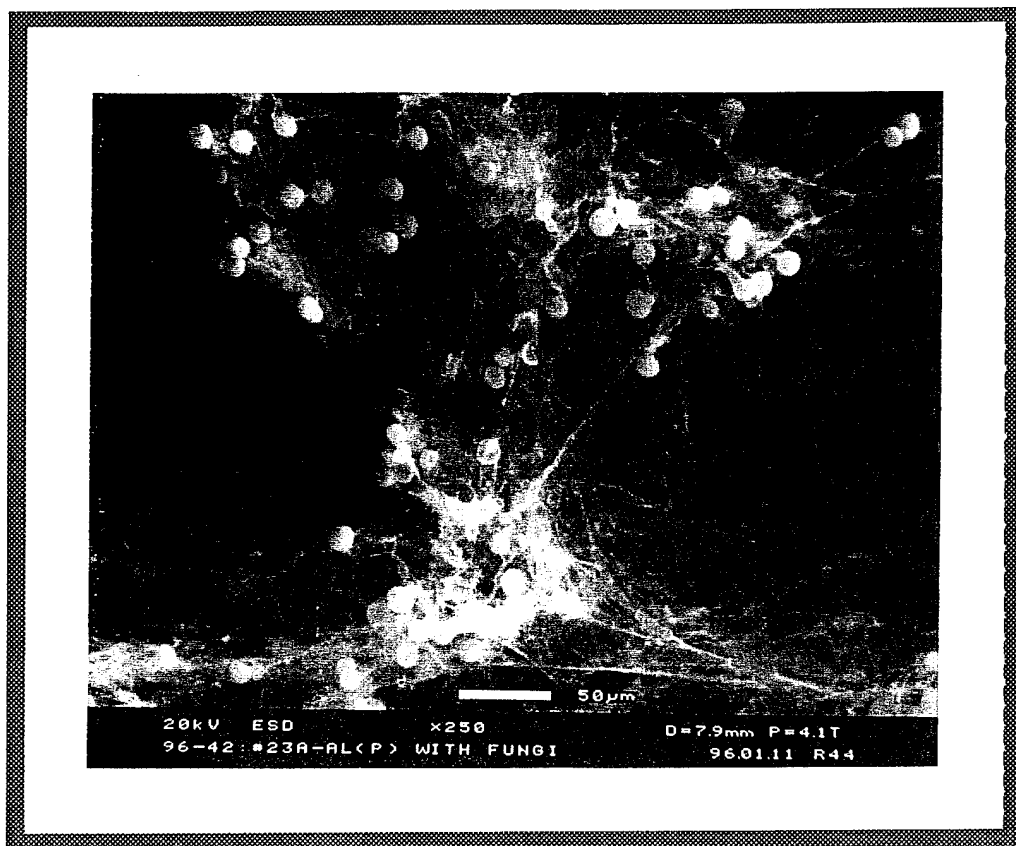
In the ESEM, fungal hyphae were well established on polyurethane surfaces. Figure 8 shows a mycelial mass with conidia, while Figure 9 shows a germinating spore. Although hyphae were firmly attached on polyurethane, there was no obvious degradation at attachment points (Figure 10). Field procedures specify swabbing with 100% isopropyl alcohol for disinfecting paint surfaces (NAVAIR 01-1A-509, T.O. 1-1-691, TM 1-1500-344-23, Aircraft Weapons Systems Cleaning and Corrosion Control). In this study, 75% ethyl alcohol was substituted as an equivalent disinfectant/cleaner. Figure 11 indicates that not all fungal structures were removed by the simulated field cleaning procedure, but remaining fungi would be expected to be non-viable due to the biocide activity of alcohol.

Figure 8: Mycelial mass on polyurethane coated coupon after 30 days (250x).

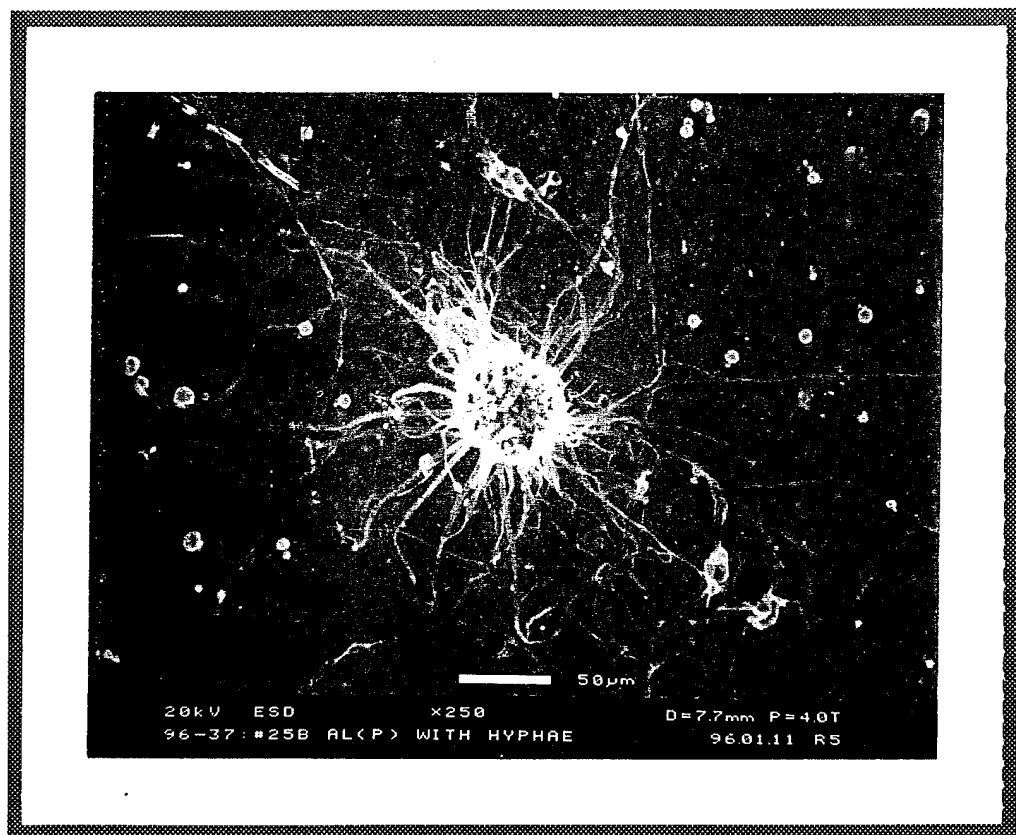
Figure 9: Germinating mycelia on polyurethane coated coupon after 30 days (250x).

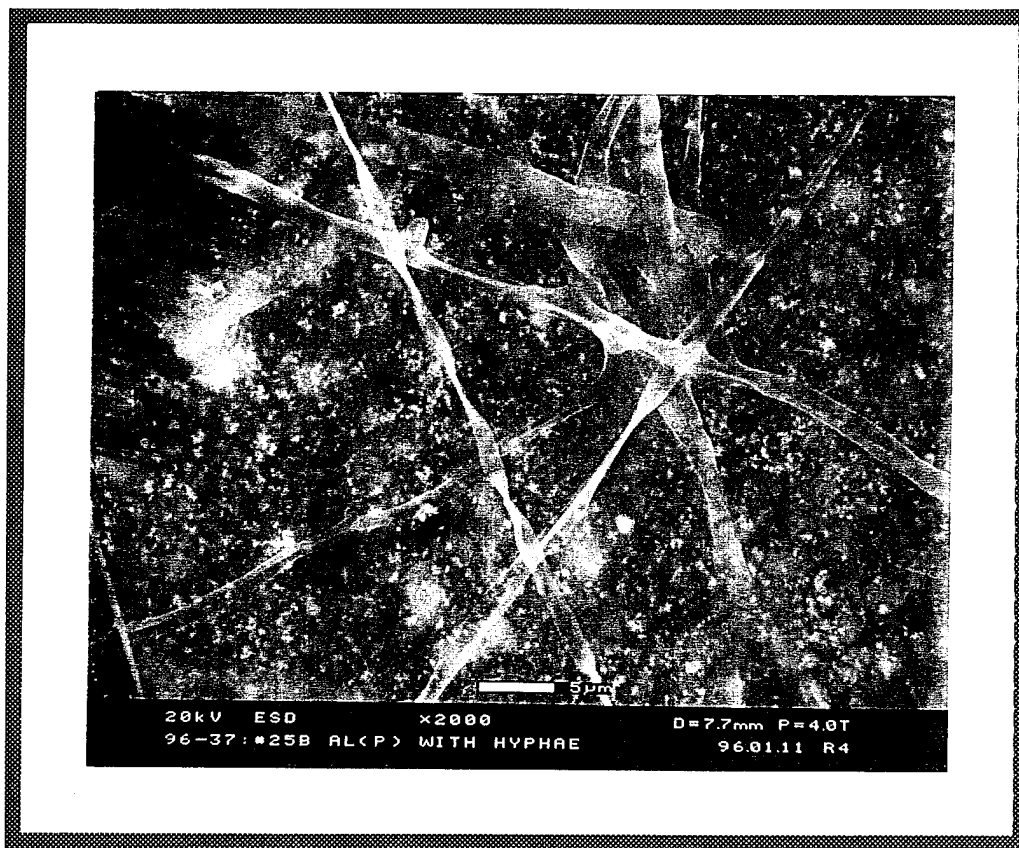
Figure 10: Hyphae attached to polyurethane coated coupon (2000x).

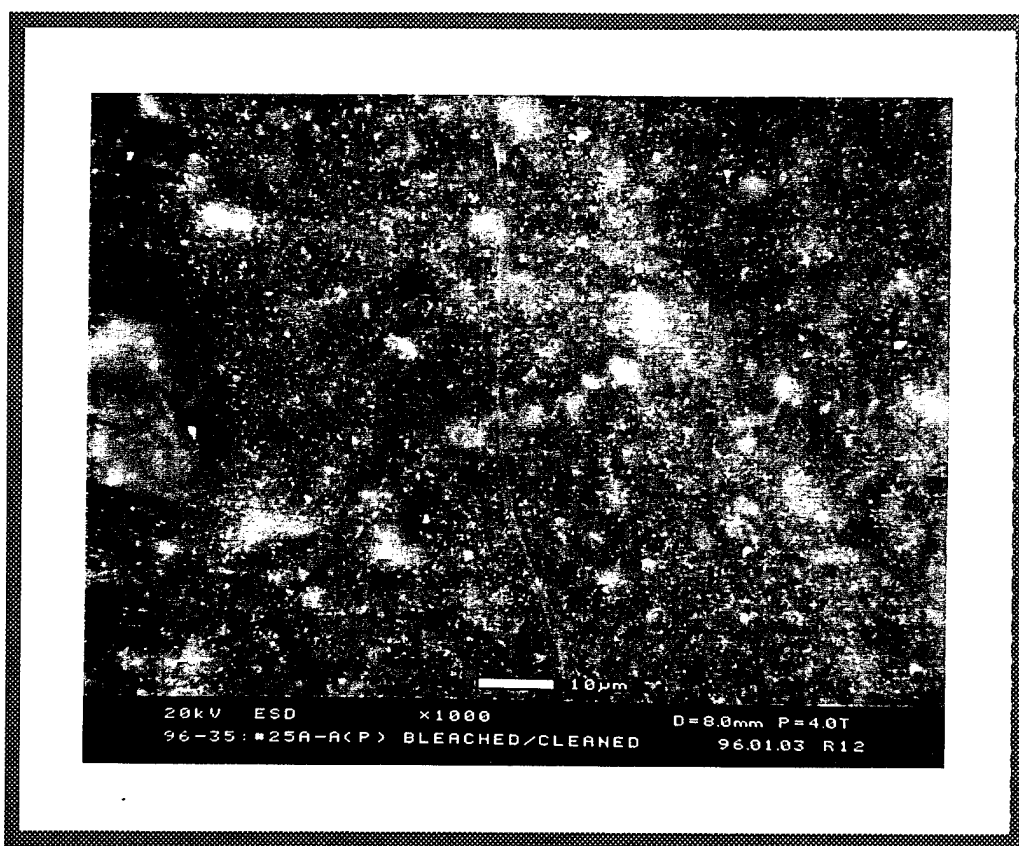
Figure 11: Polyurethane coated coupon surface after alcohol cleaning (1000x).

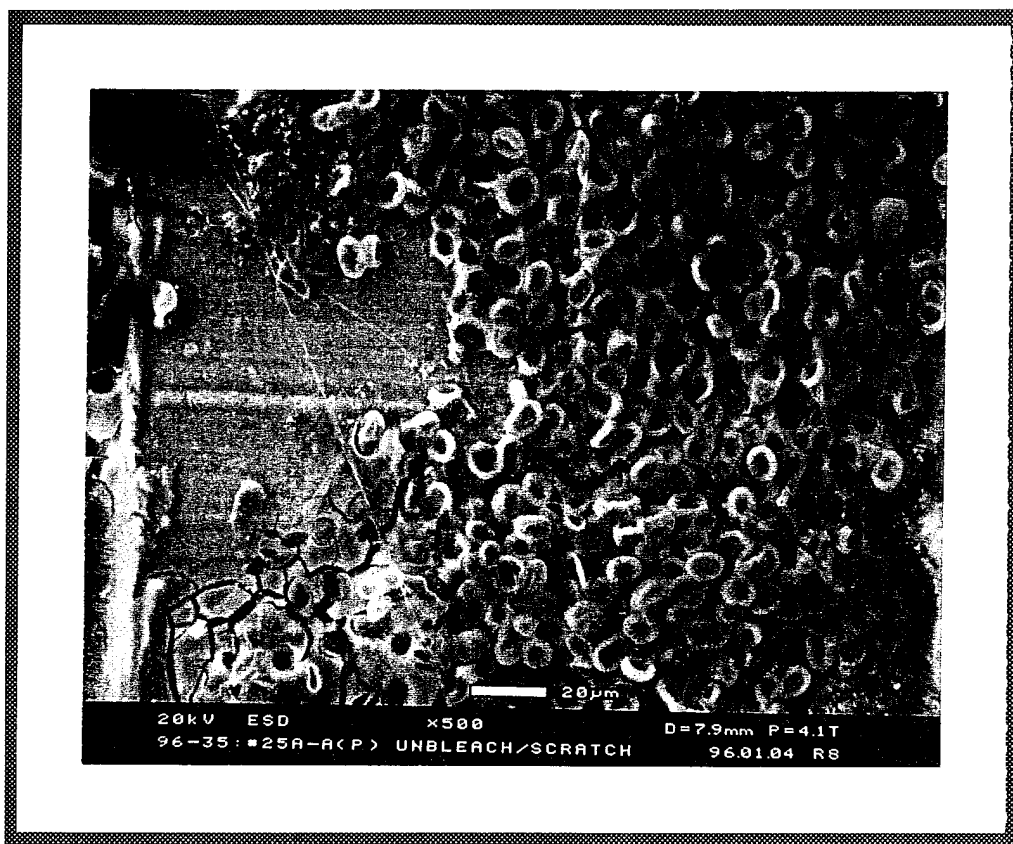
Fungi were present in the unbleached half of the scratches on many coupons, along with occasional corrosion products (Figure 12). Hyphae were also present on the bleached half of the scratches where corrosion was heavy (Figure 13), but corrosion was attributed to oxidation by sodium hypochlorite.

The mechanism for such an effect was not investigated, but Videla (1986) concluded that *Cladosporium* enhanced corrosion of aluminum by producing acidic metabolic products. There is some evidence from ESEM microscopy (Figure 12) that fungi were physically associated with corrosion products formed on aluminum exposed in scratches made in the protective coating. Paint defects are to be expected during the normal duty cycle of military helicopters and may be particularly vulnerable.

Figure 12: Fungal spores in scratch exposing bare metal, unbleached portion. Note hyphae at 11 o'clock and corrosion at 7 o'clock. (500x)

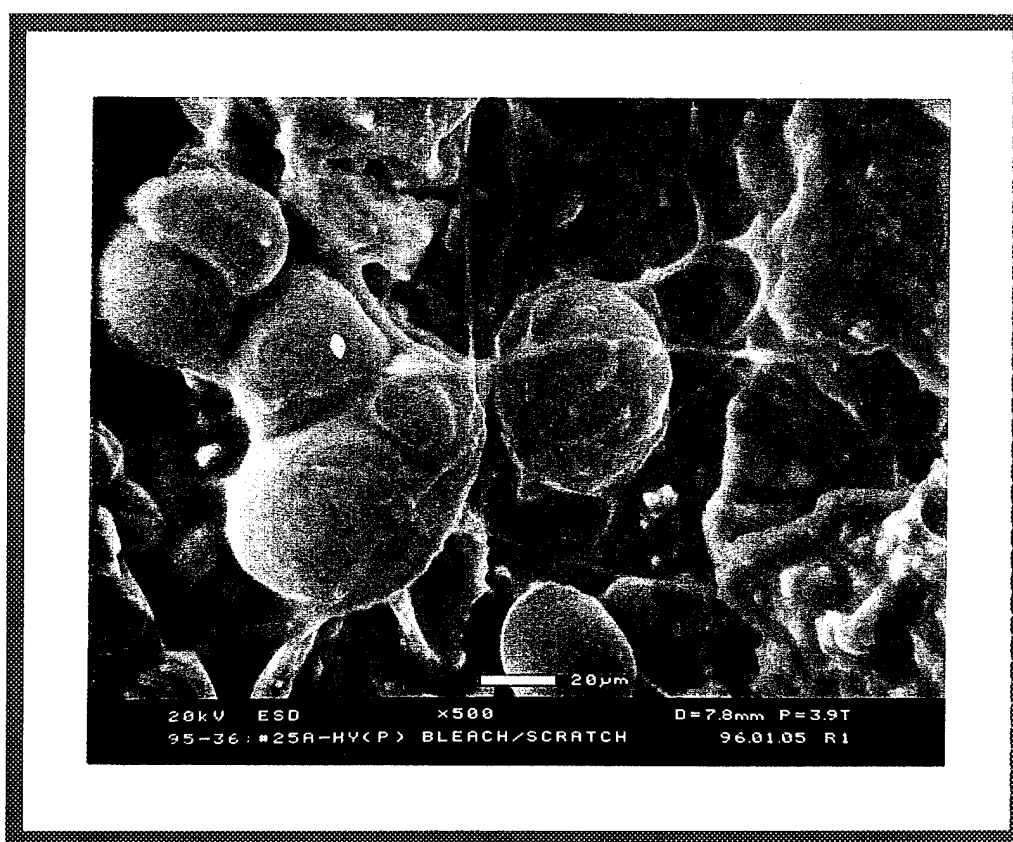
Figure 13: Hyphae on corrosion product in bleached portion of scratch (500x).

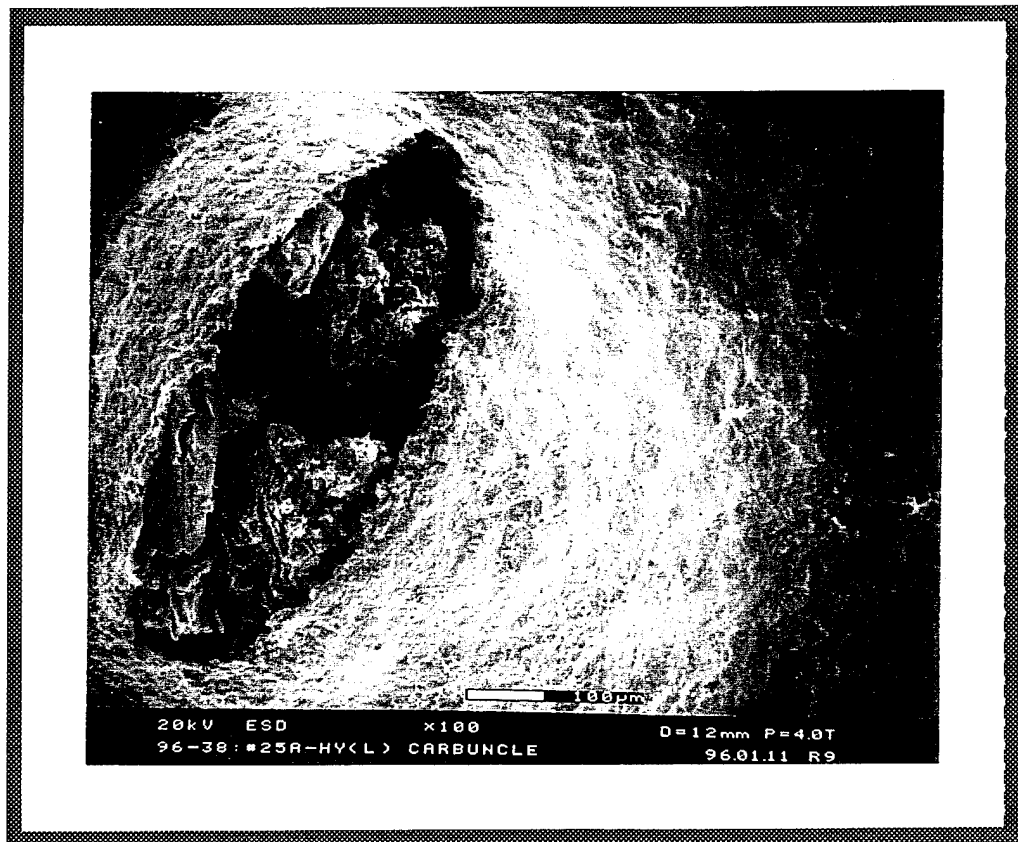
No corrosion or blistering occurred on polyurethane-coated coupons; however, a few blisters were observed on lacquer-coated coupons, mostly close to the central scratch. Although there were few signs of fungi inside the blisters (Figure 14) blister sides were covered with fungal mycelia (Figure 15).

Figure 14: Blister with corrosion on lacquer paint (100x).

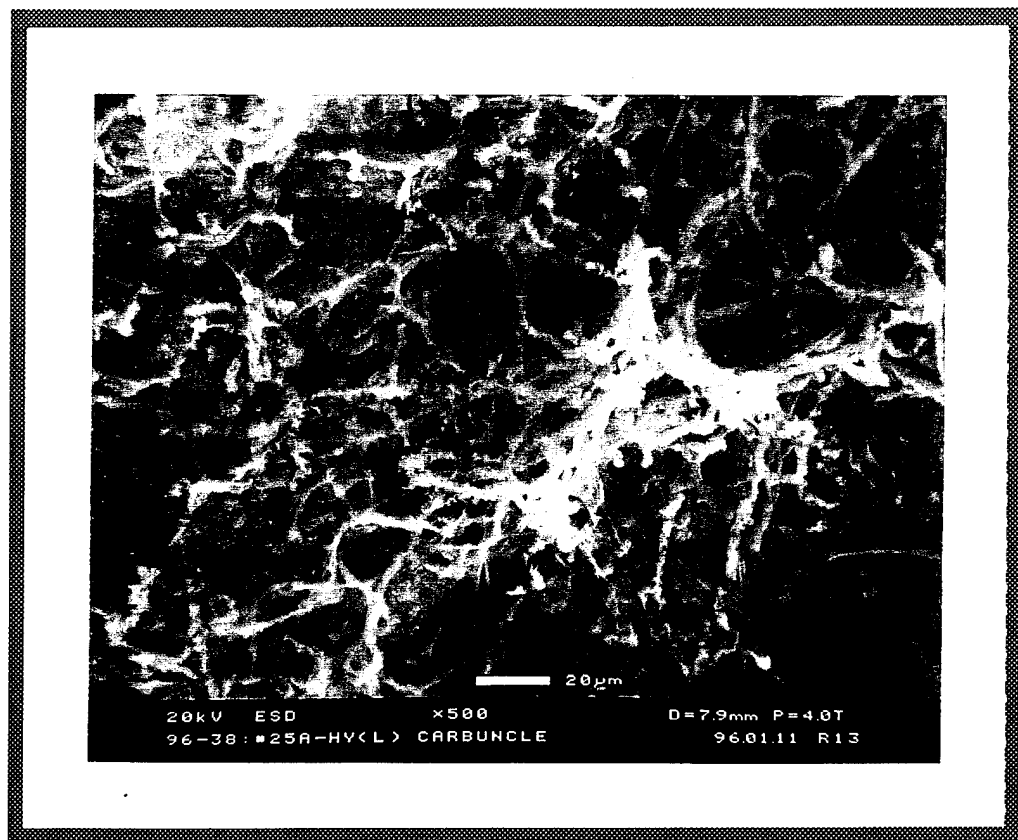
Figure 15: Fungal mycelia covering sides of blister in Fig. 14 (500x).
